## 2.0 ANALYSIS

## **2.5 Analysis of the chronological main events**

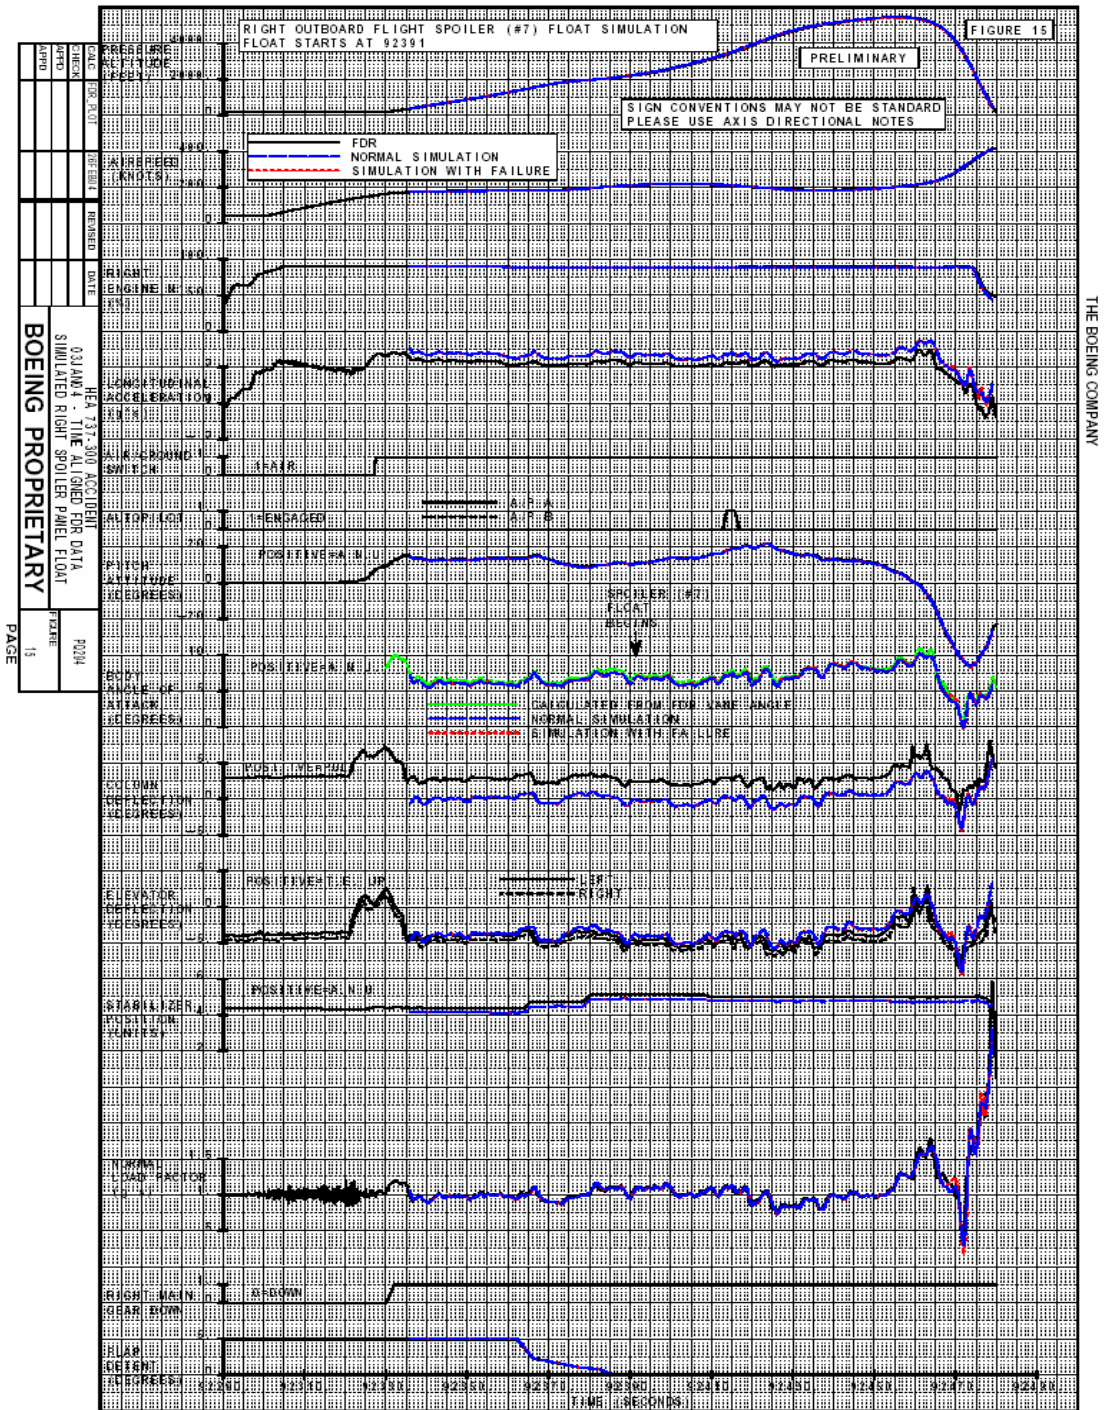
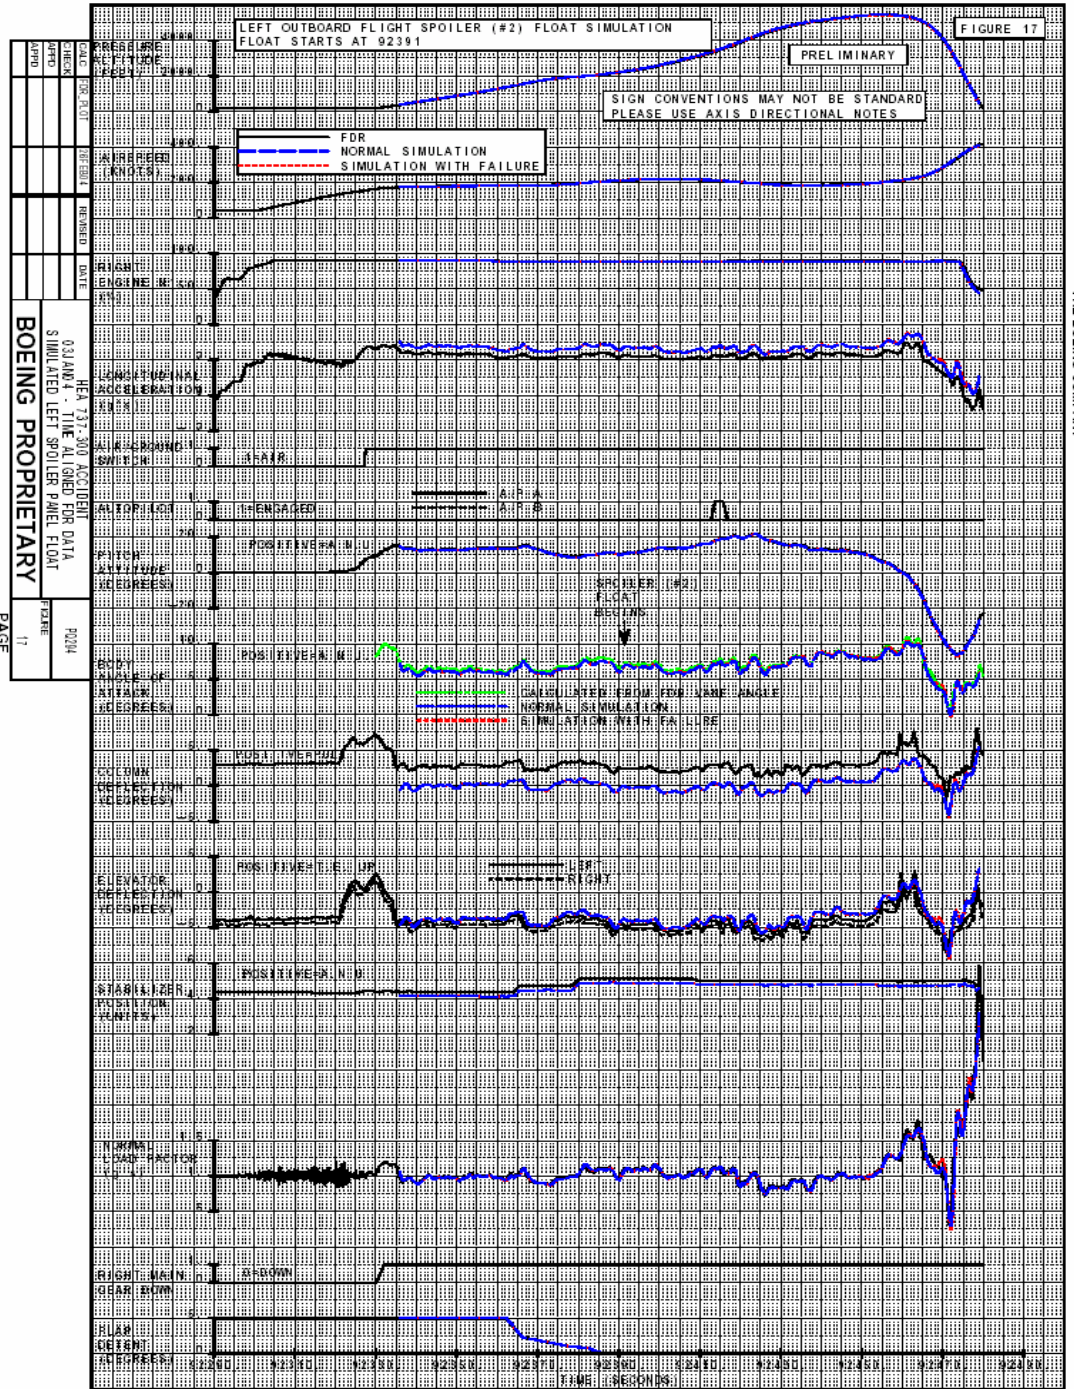
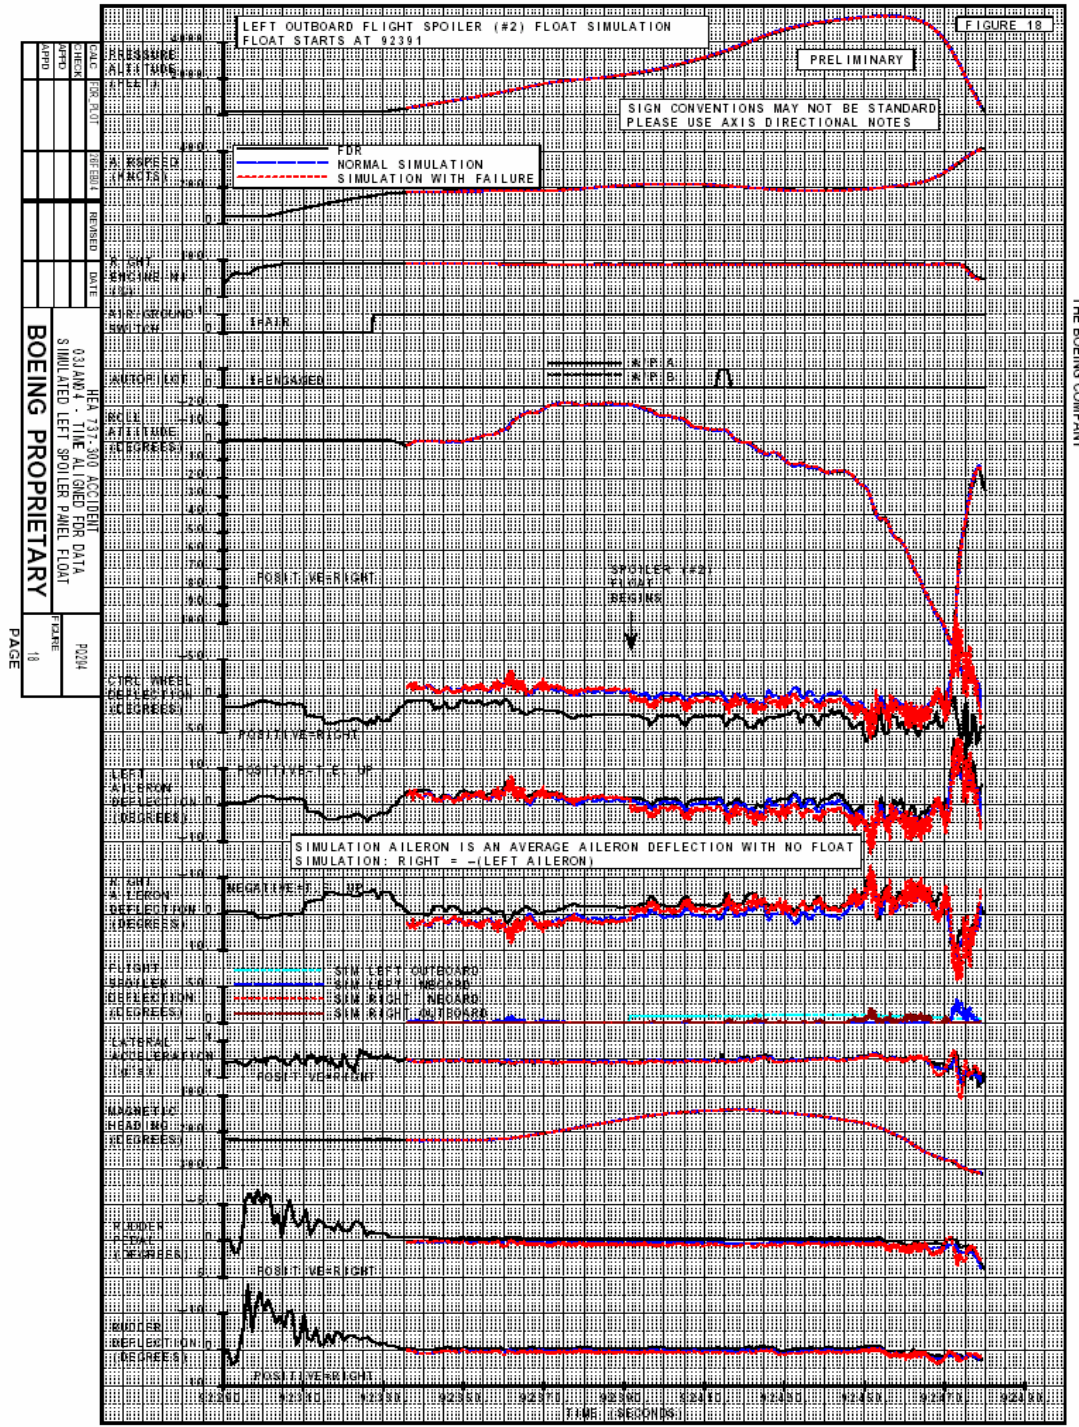
Based on the M- Cab results (Simulator match to FDR, Faults Simulations, results of spoilers' float conditions are shown hereafter), this condition shows inconsistency with the accident scenario. Therefore, this fault could be ruled out.

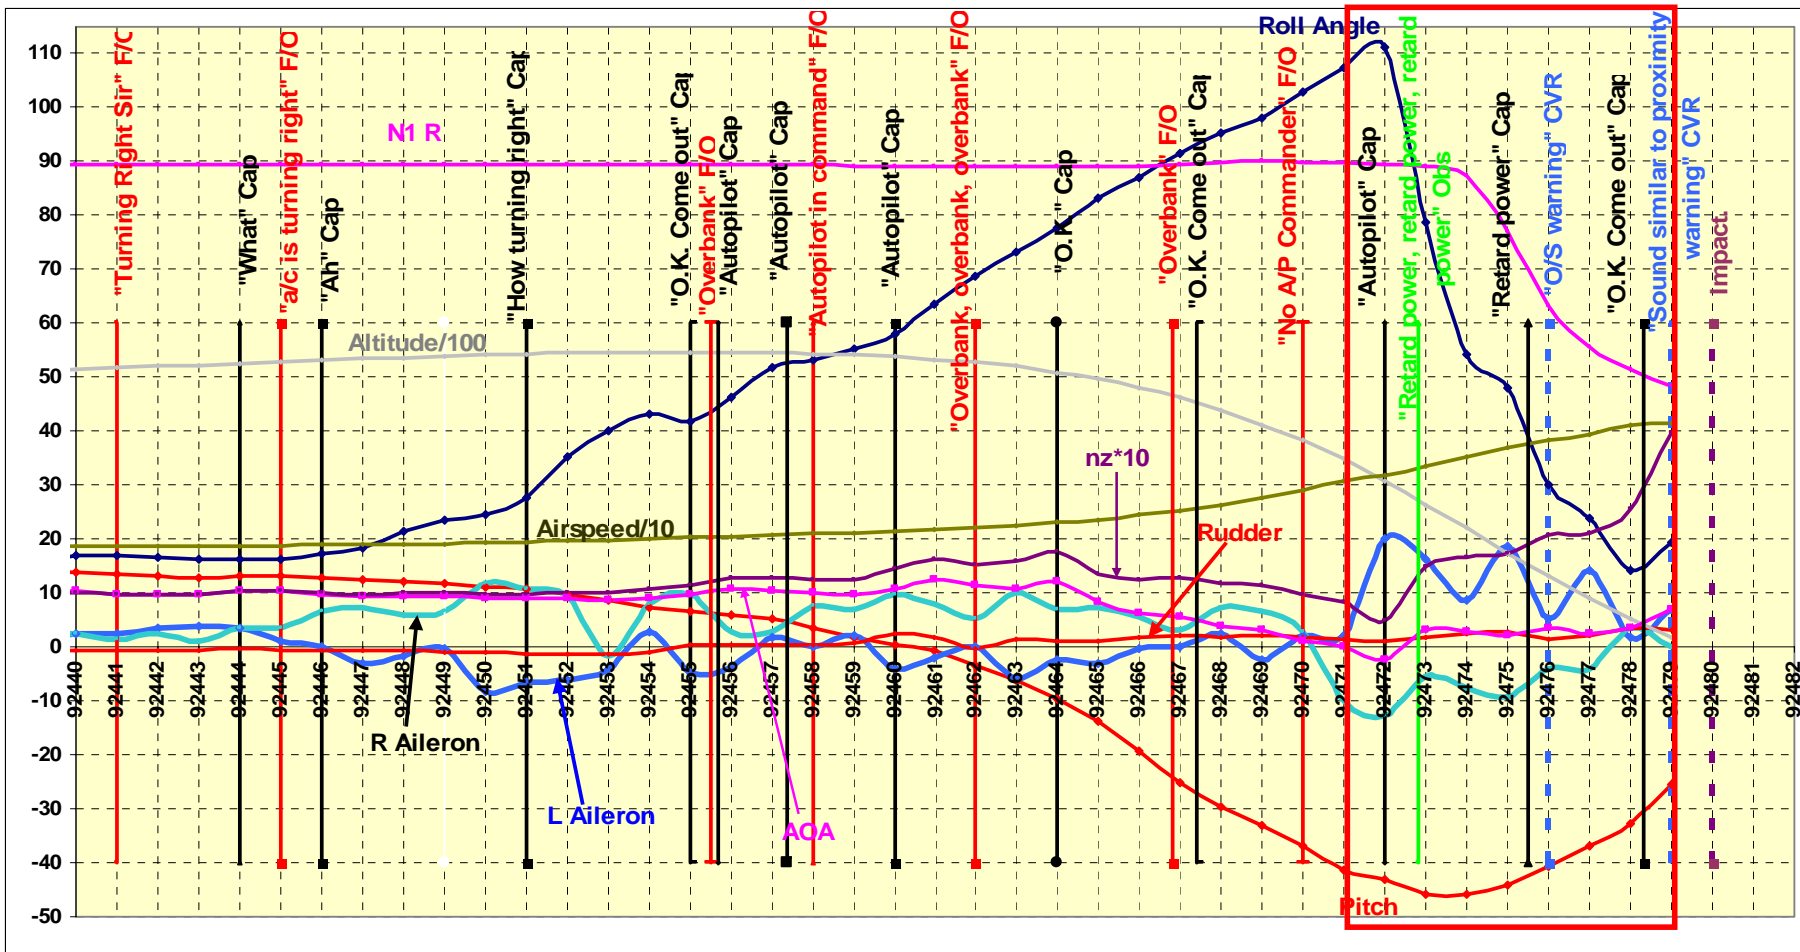
Figure 2.5.15 Rapid left roll towards wings level

From the above, Captain Upset Recovery Attempt seems a higher possibility
